**NORWAY/UNITED STATES DESIGN PROTECTIVE
AIRCRAFT SHELTER (PAS) QUANTITY-DISTANCE
PROGRAM 1/3-SCALE TEST SERIES**

**Volume I of V
PAS 1-4 Summary**

Final Report

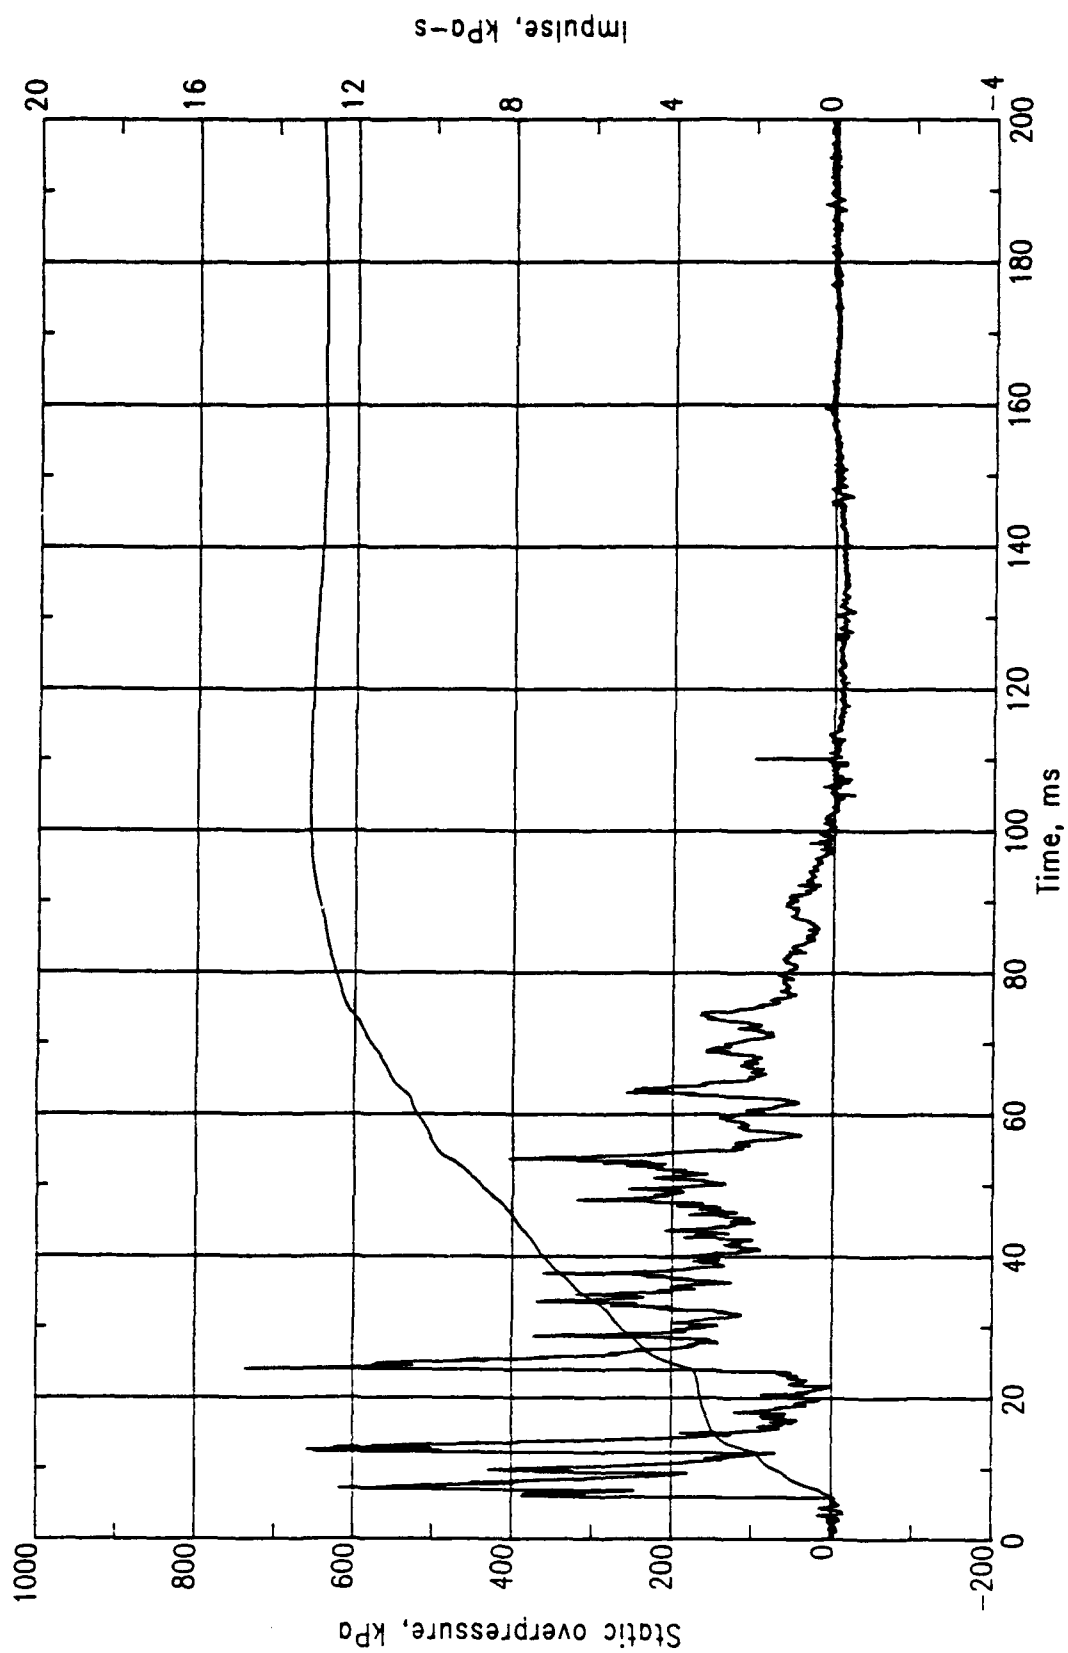
Figure 177. PAS-2, MN 0402.

The only pressure measurement made on the inside surface of the front door in the PAS-2 test was MN 402 (Fig. 177). This gage was located near the center of the door, and it recorded a peak pressure of 0.74 MPa at 24 ms. The INBLAST code predicted a

peak of 0.76 MPa at 7.5 ms at this location. The recorded peak at this time was 0.63 MPa. Measurement Number 201, located in the backwall at about the same range and distance off the structure centerline but at a slightly greater height, shows a peak of 1.27 MPa (Fig. 178). Amplitude differences are also noted between MN 405 in the front wall and MN 203 at a similar location in the backwall. The peak pressure recorded at MN 405 was 2.26 MPa (Fig. 179); at MN 203 it was 6.2 MPa (Fig. 180). These two records had similar characteristics, except for the amplitude of their peaks.

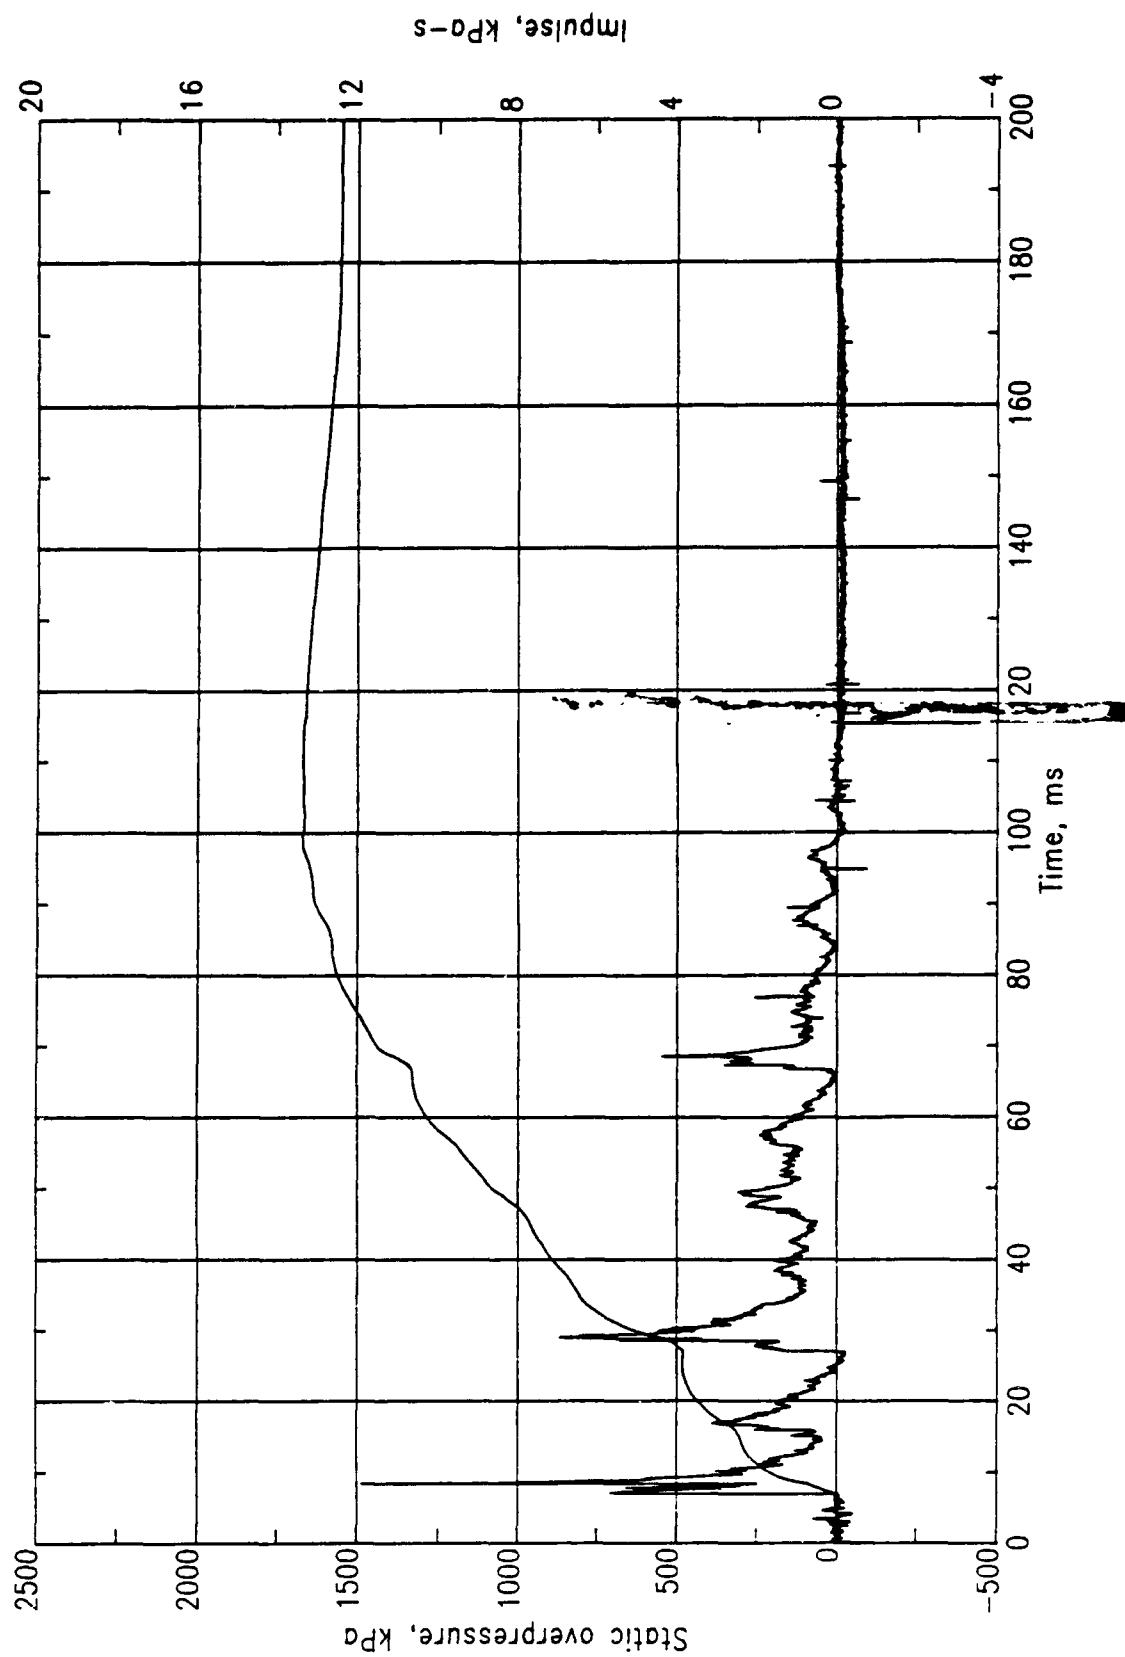
Figure 181. PAS-2, MN 0501.

Measurement Number 501 located in the floor at the front corner of the shelter showed a peak pressure of 1.5 MPa (Fig. 181). Measurement Number 102 located in the floor at the rear corner of the shelter shows a higher peak of 1.95 MPa at the same time (Fig. 182).

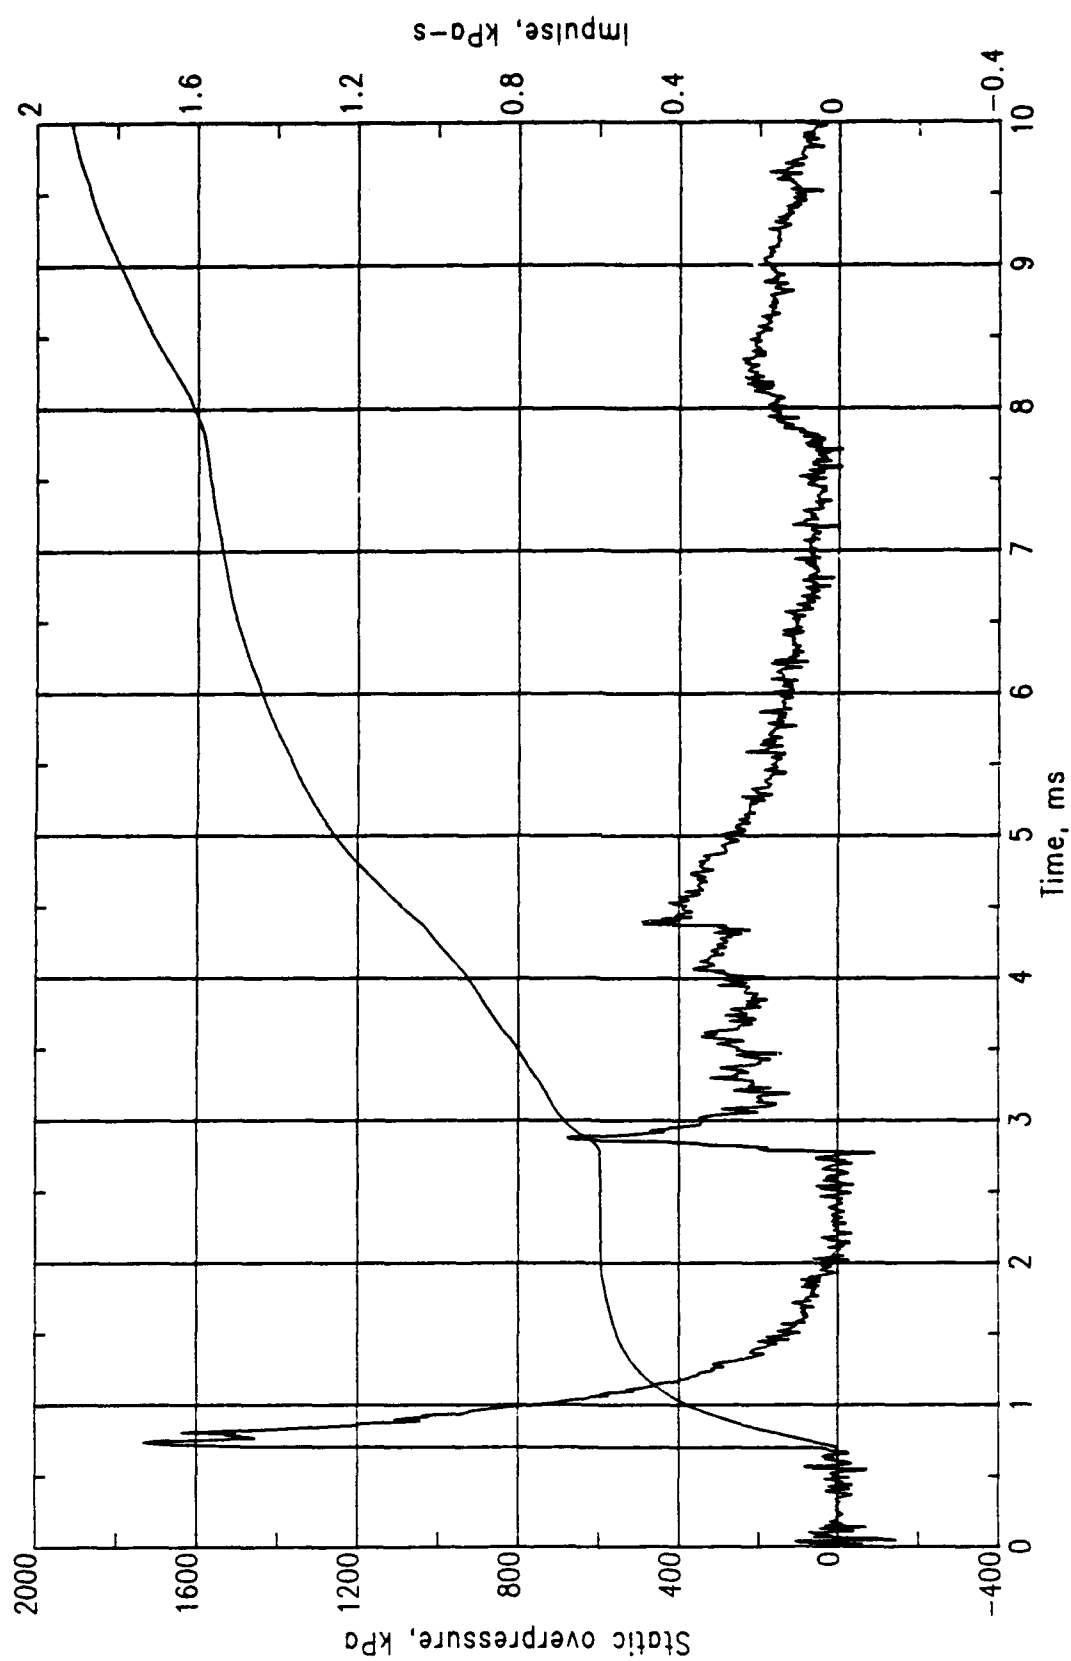
Figure 183. PAS-2, MN 0601.

Measurement Number 601 was made in the floor 1.85 m from GZ towards the side of the shelter (Fig. 183). It shows a peak pressure of 1.7 MPa. The INBLAST code predicted 2.7 MPa at this location. Measurement Number 301, made in the floor 2.84 m from GZ towards the front door, shows a peak of only 0.5 MPa (Fig. 184).

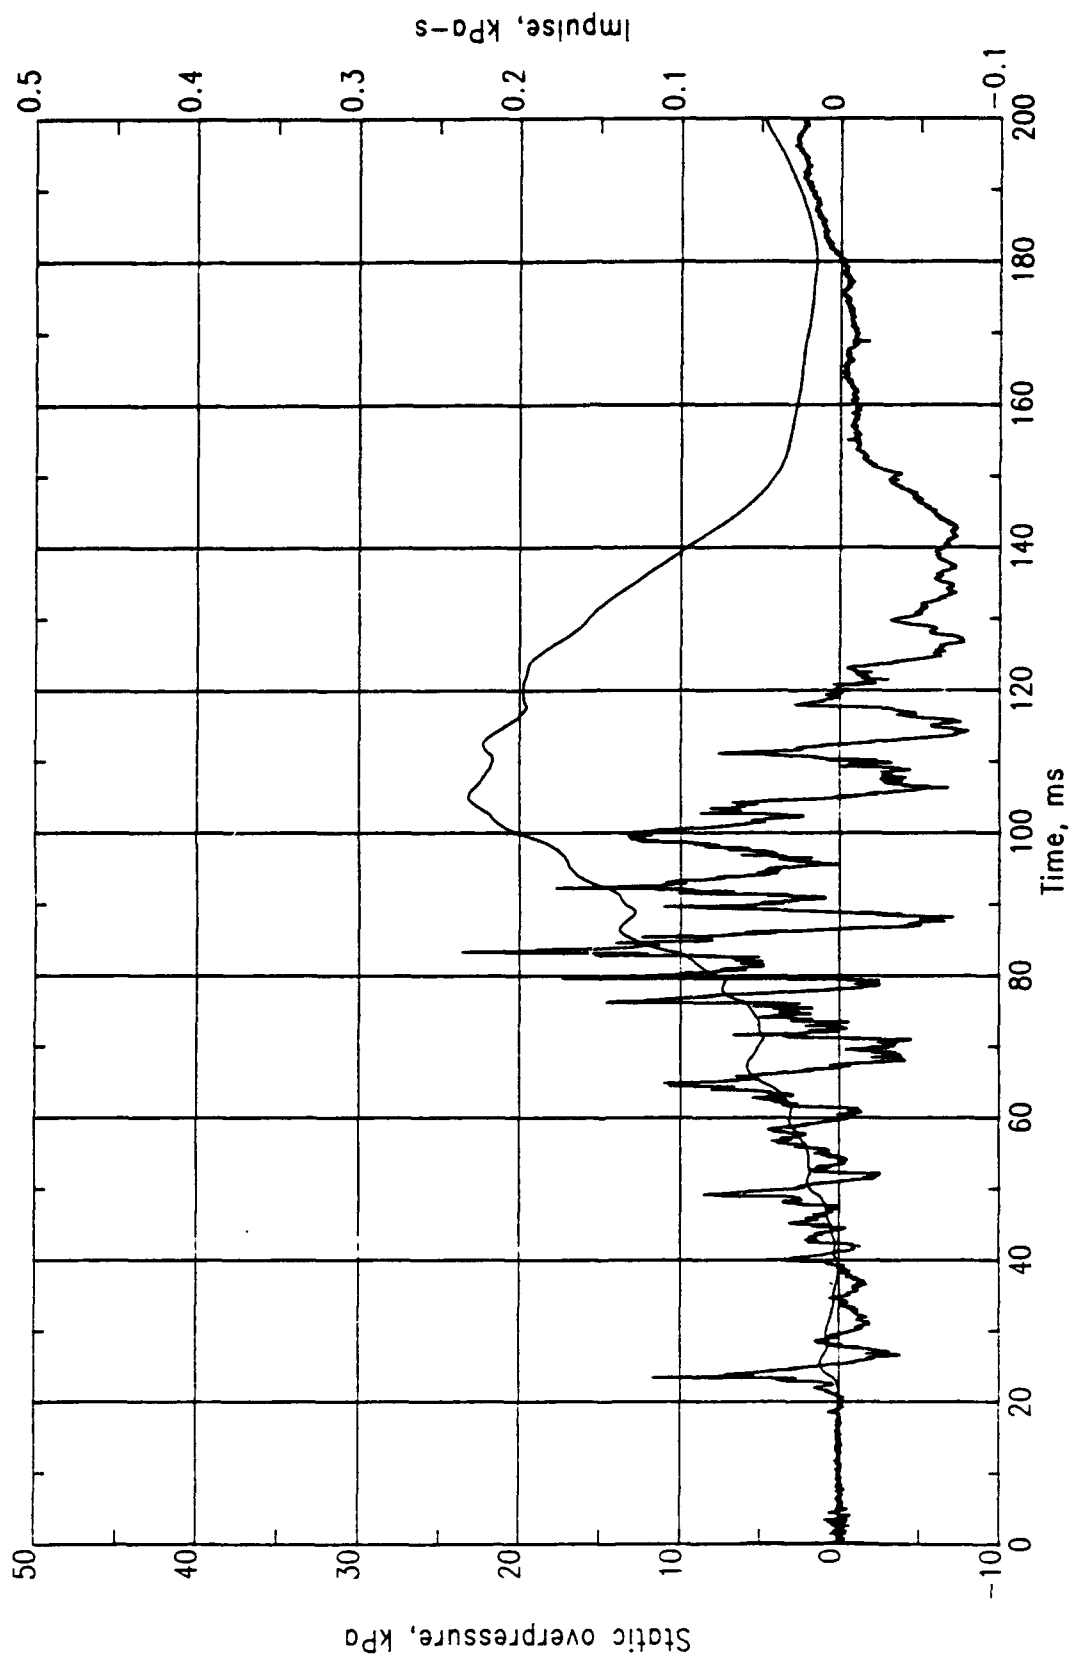
Figure 185. PAS-2, MN 0701.

The initial peak of only one free-field measurement exceeded 6.9 kPa. Measurement Number 701 located 11.8 m from the GZ recorded a peak of 11.5 kPa (Fig. 185). Measurement Number 702 located at 15.8 m from GZ recorded 6.5 kPa (Fig. 186). However, MN 701 showed a peak of 25 kPa at 83 ms and MN 702 a peak of 16.2 kPa at 93 ms. If the maximum values are considered, the 6.9-kPa contour would occur at about 30 m from GZ at the front of the structure. Measurement Number 704 at a range of 30.8 m recorded a peak of 6.5 kPa.

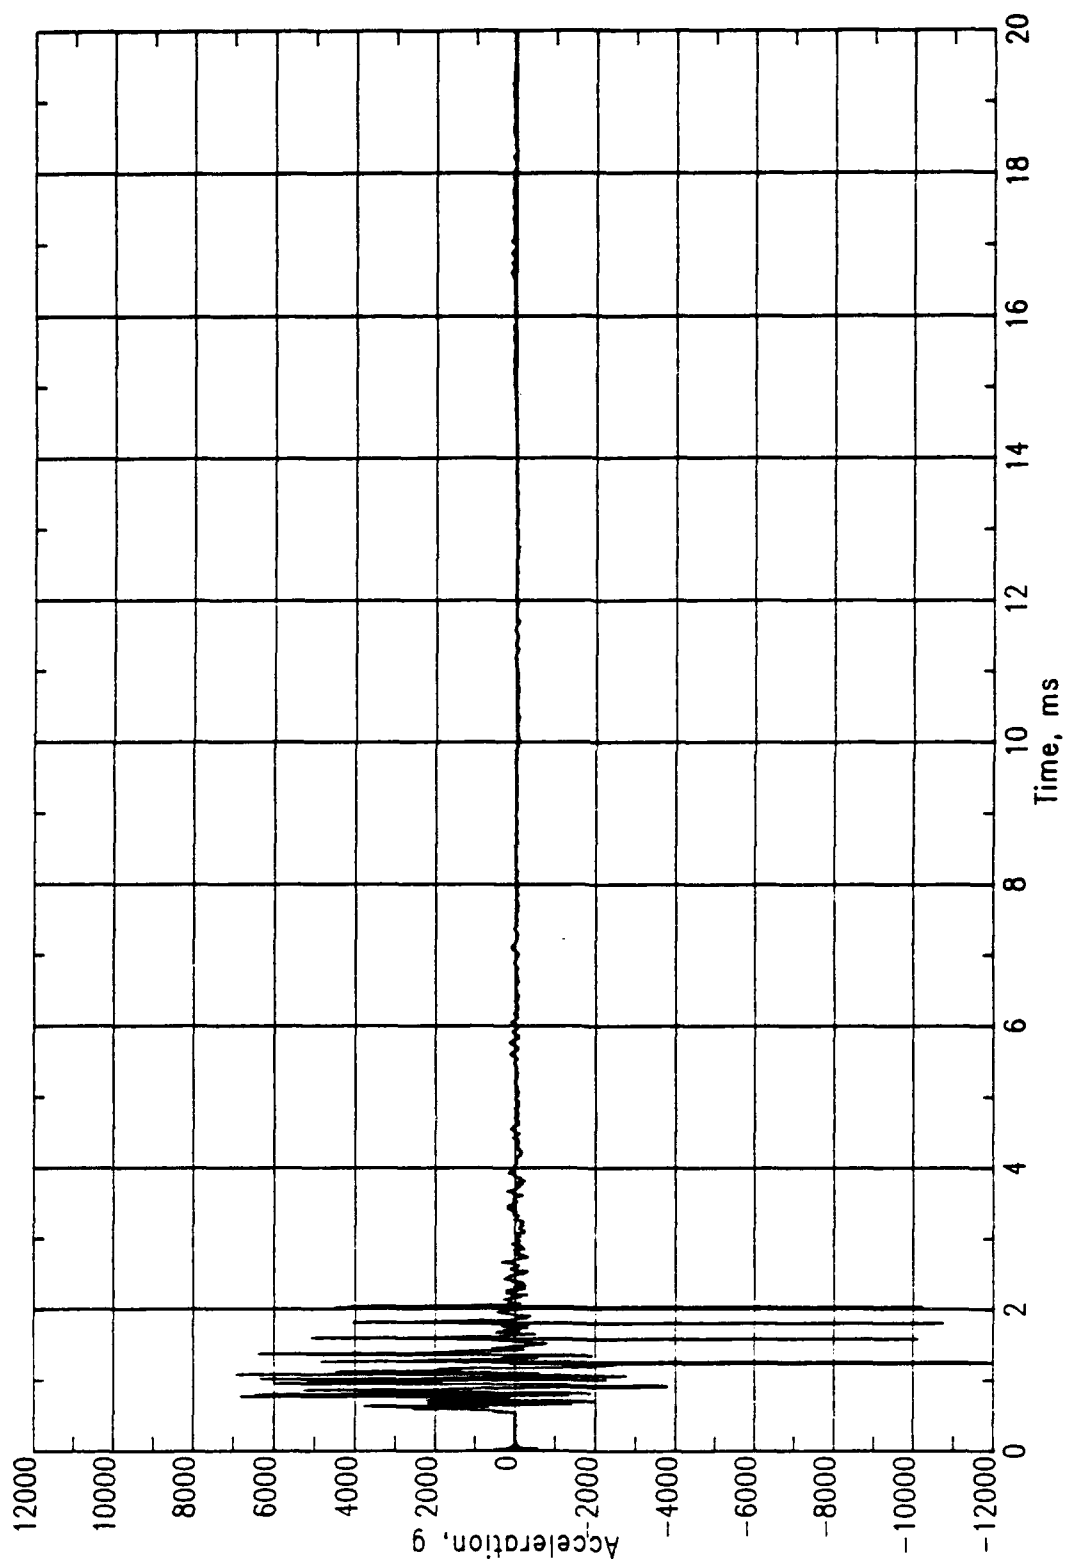
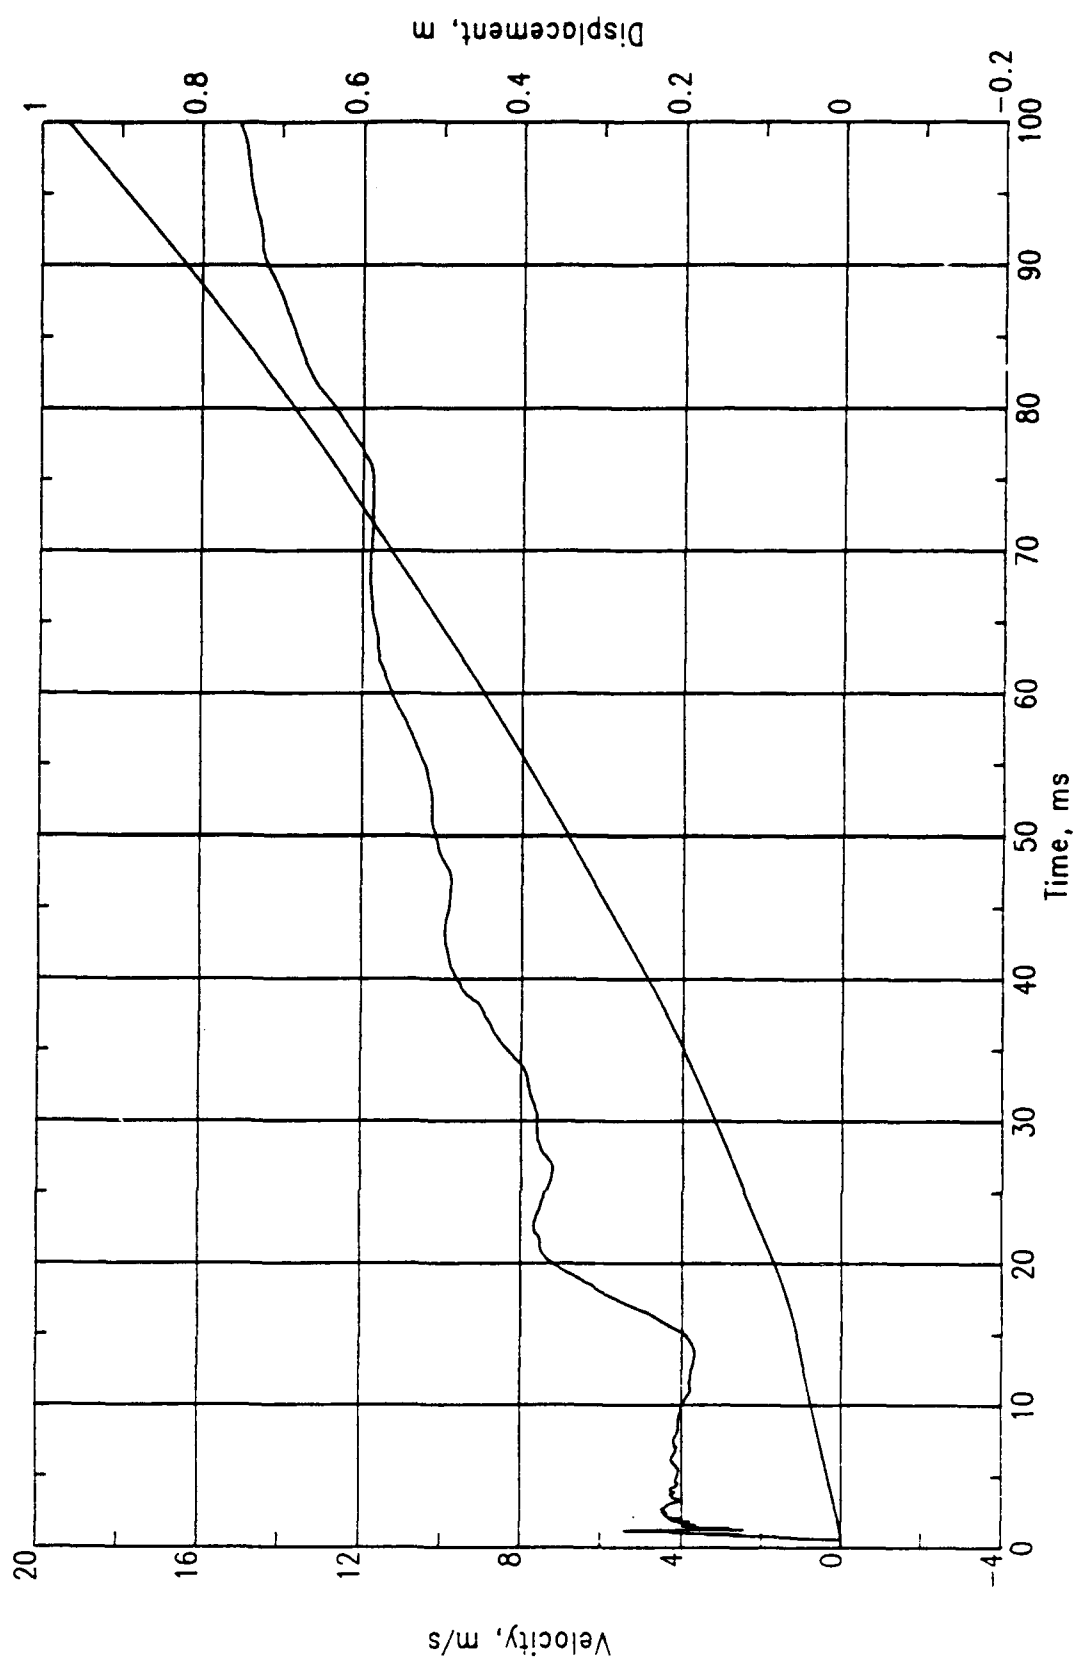
Figure 187. PAS-2, MN 1601.

Measurement Numbers 1601 and 1602 were made at the crown of the arch directly above GZ. Although numerous noise spikes made it difficult to read a peak from the record of MN 1601 (Fig. 187a), expansion of the first 5 ms of this record indicates a peak radial acceleration of about 7000 g. The higher negative peaks between 1 and 2 ms appear to be noise rather than real data. A similar expansion of the time base for MN 1602 indicates a peak tangential acceleration of 540 g. Figure 187b, a plot of the first and second integrals of the accelerometer record for MN 1601, shows a peak radial velocity of 5.4 m/s during the first 10 ms of the record. This velocity is slightly lower than the 6.3 m/s derived from high-speed photography for the entire front portion of the

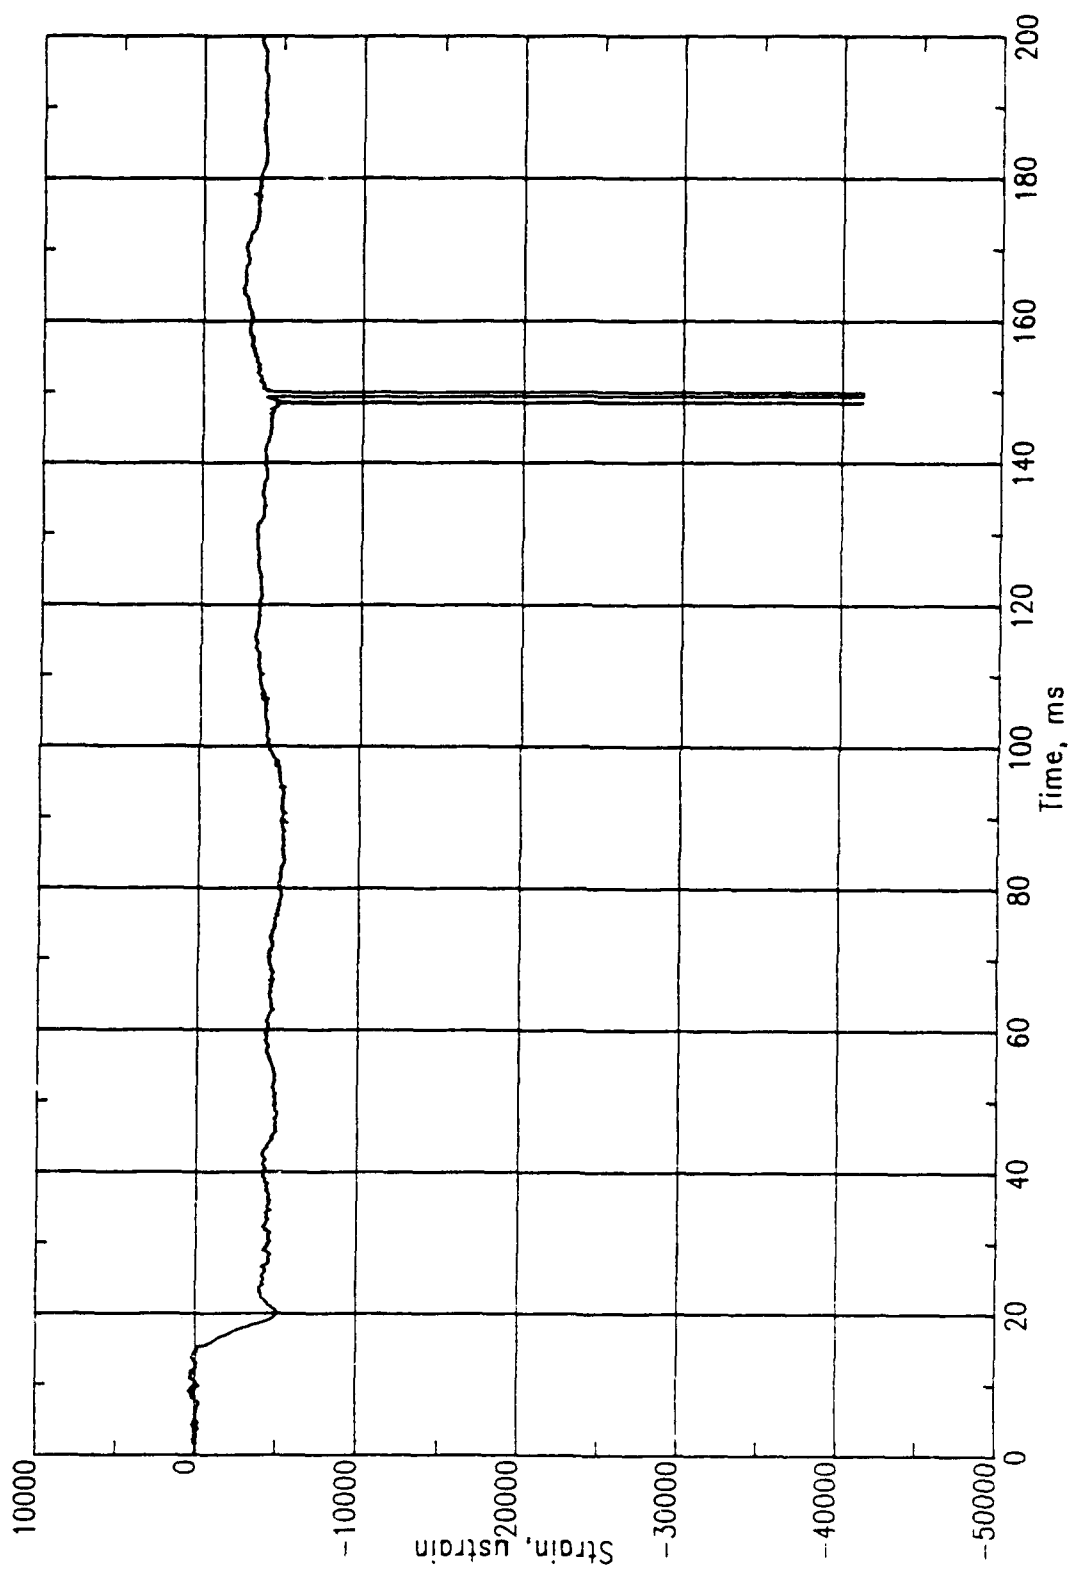
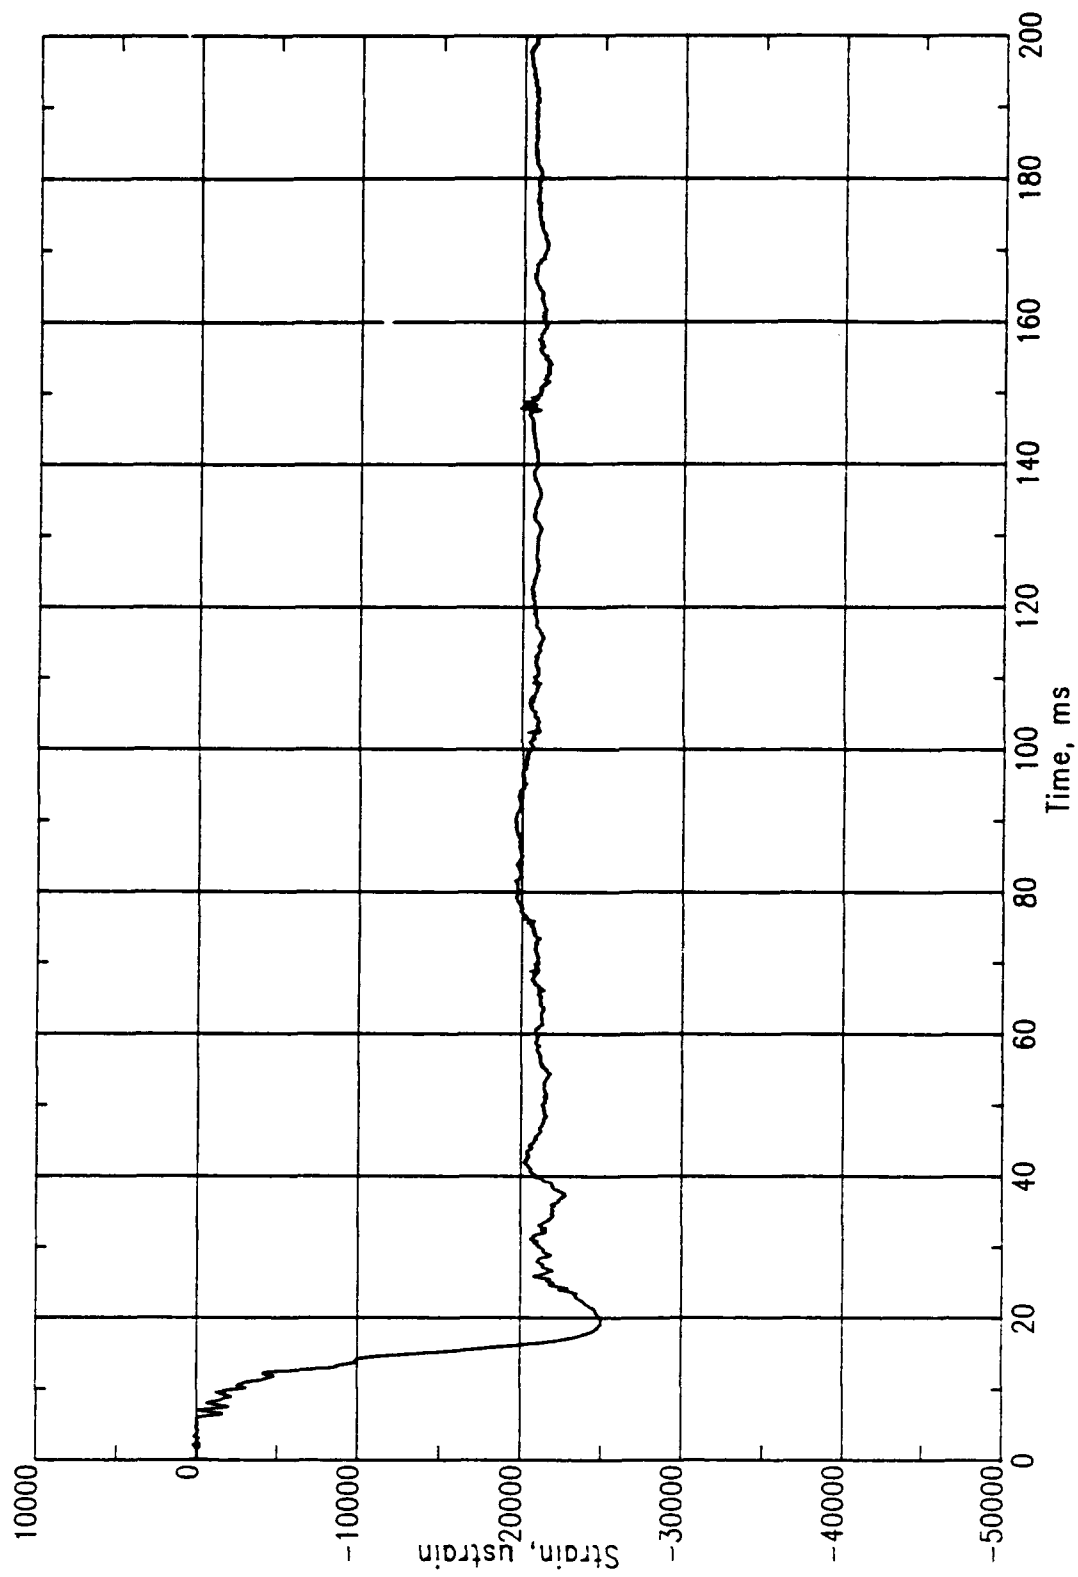
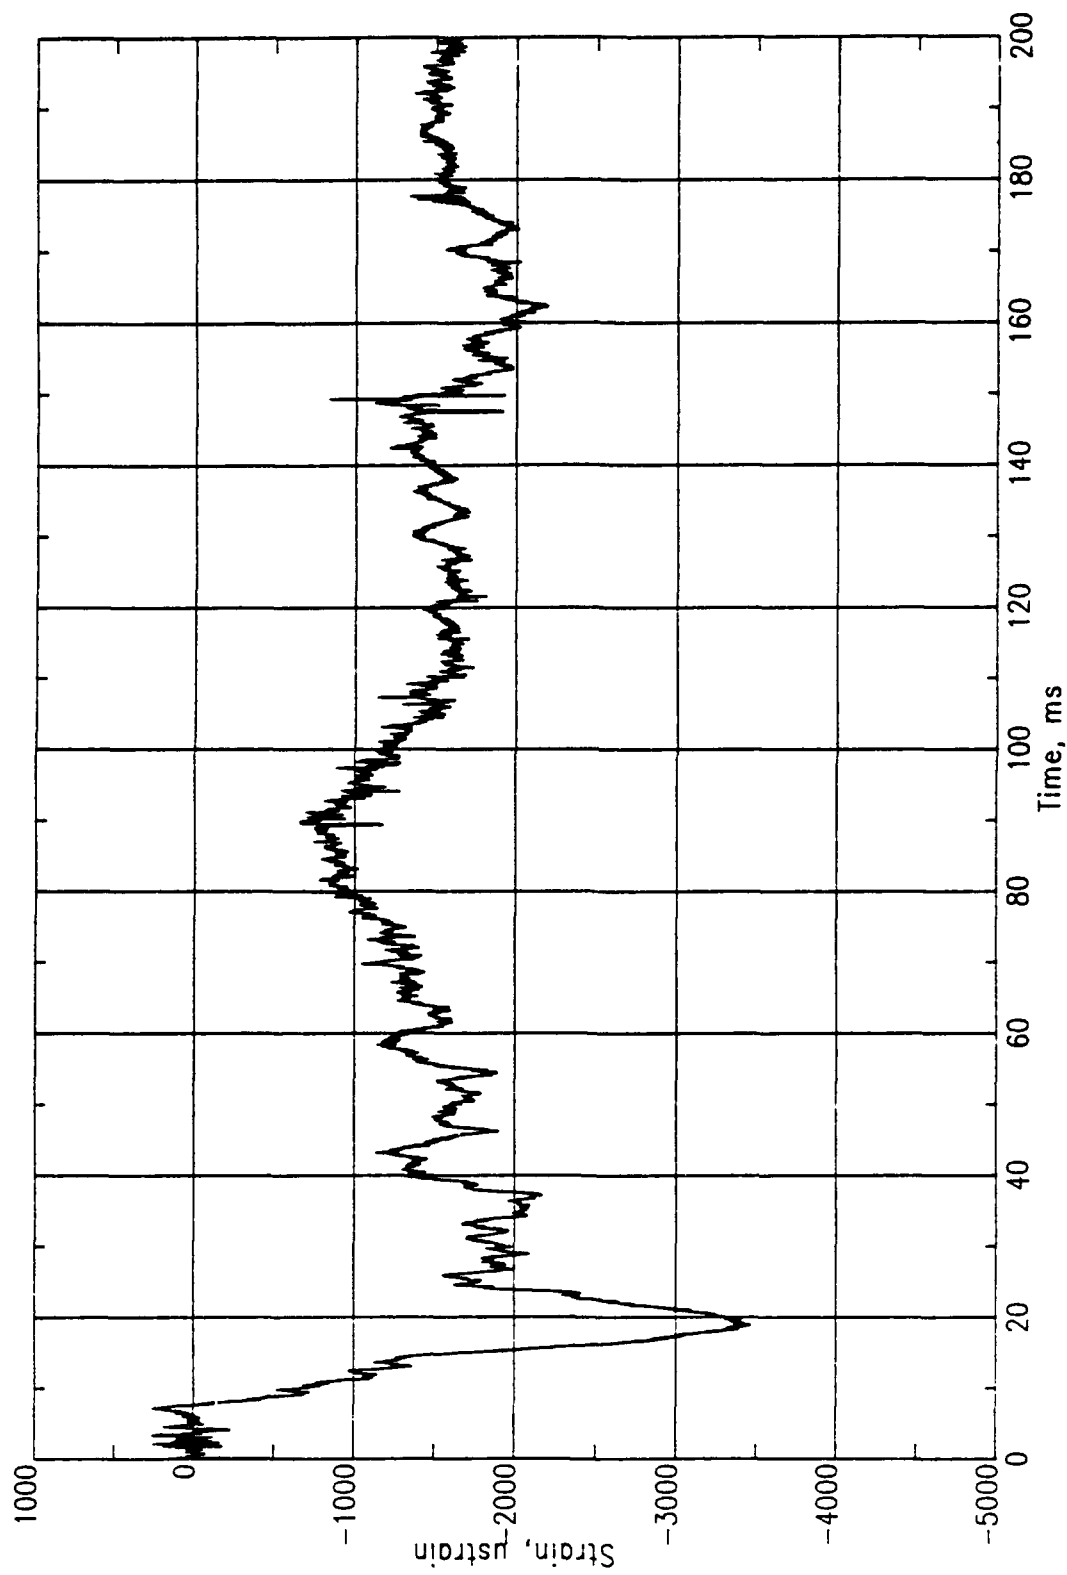
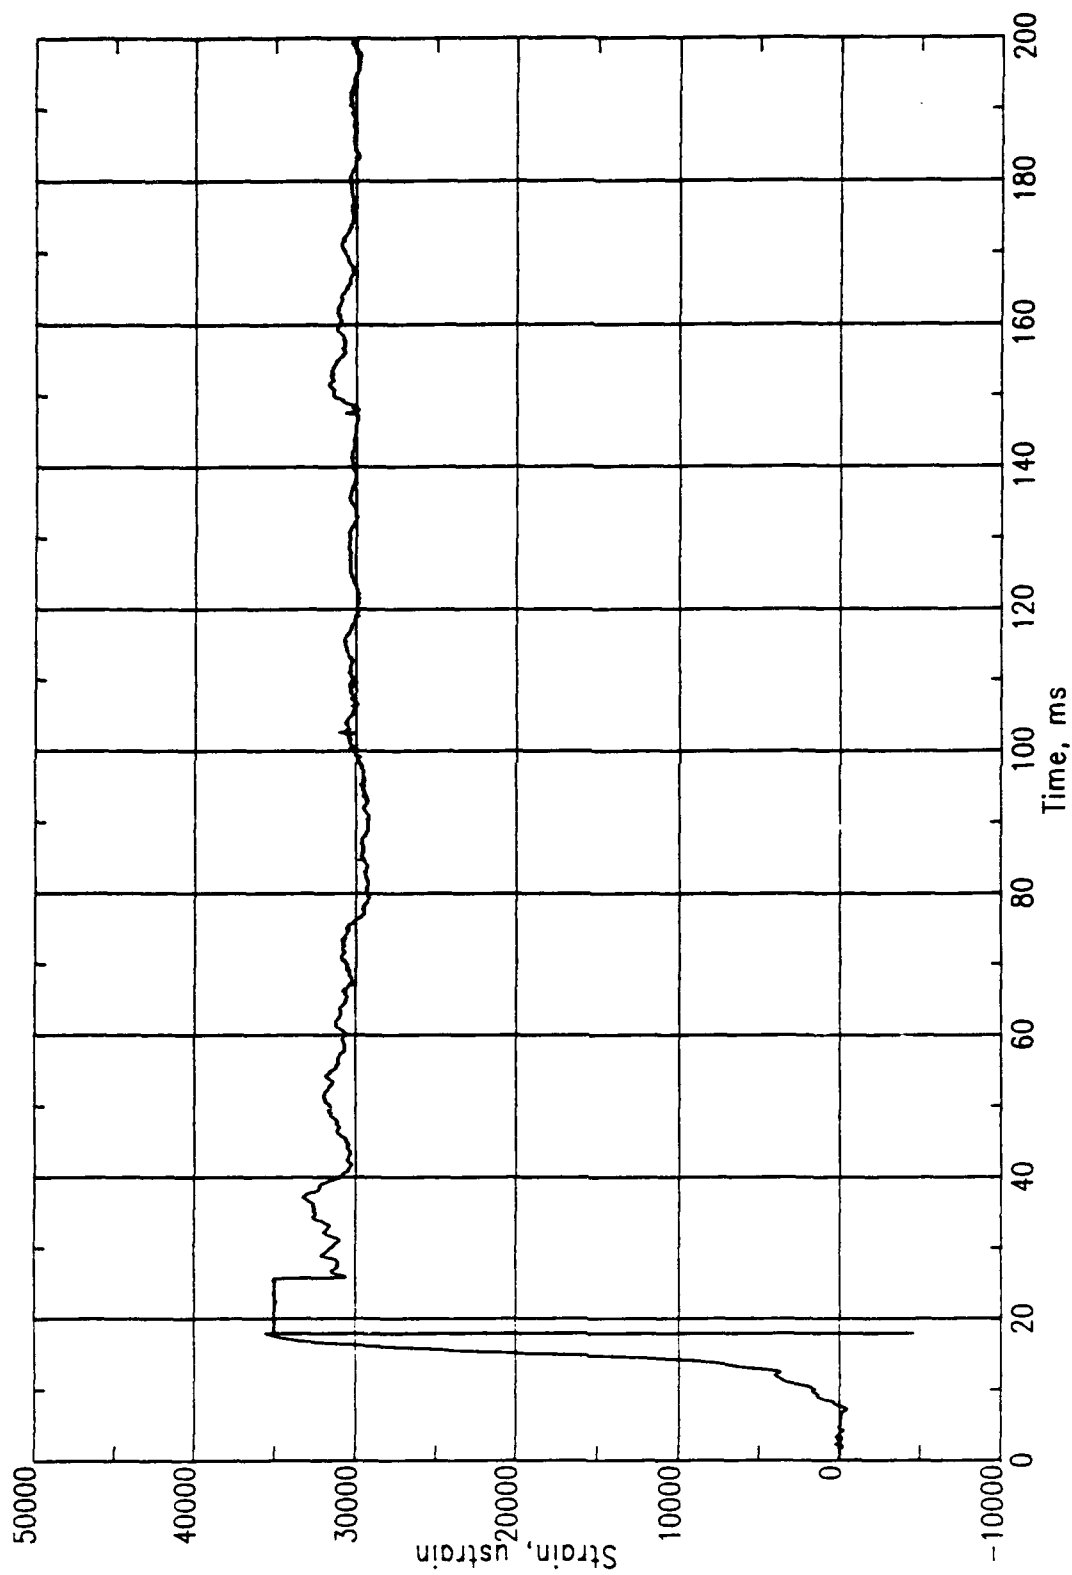
Two pairs of strain gages were mounted about mid-height on the centerline of the door. One gage of each pair was mounted on the inner surface of the door and the other on the outer surface. One pair was oriented to measure vertical strains (MN 3402 and MN 3404) and the other to measure horizontal strains (MN 3401 and MN 3403). At about 20 ms MN 3401 shows a horizontal tensile strain of 5000 microstrain in the outside plate of the door (Fig. 188). At the same time MN 3403 shows a horizontal tensile strain of 25,000 microstrain in the inner plate (Fig. 189). Measurement Number 3402 shows a vertical tensile strain of 3500 microstrain in the outer plate at 19 ms (Fig. 190). At about the same time MN 3404 exceeded its recording bandwidth, but it shows a compressive strain in excess of 35,000 microstrain in the inner plate (Fig. 191). The linear range for all gages is 20,000 microstrain. Greater recorded values are subject to some uncertainty.

Although the observed general characteristics of vertical strains are consistent with outward bending of the door, they are not consistent with pure bending. The higher compressive strains in the inner plate would normally indicate an axial compressive force had been applied to the door. This does not appear to be a probable explanation of this measurement discrepancy. The horizontal strains are also inconsistent with outward bending of the door. For the observed mode of response, i.e., outward bending, no combination of bending plus axial loads would produce greater tensile strains in the inner plate of the door. There was some buckling of the inner plate of the door in the vicinity of the gages, and this buckling could have affected the recorded strains. The strains recorded in PAS-2 are consistent with results observed in PAS-1 and PAS-3.

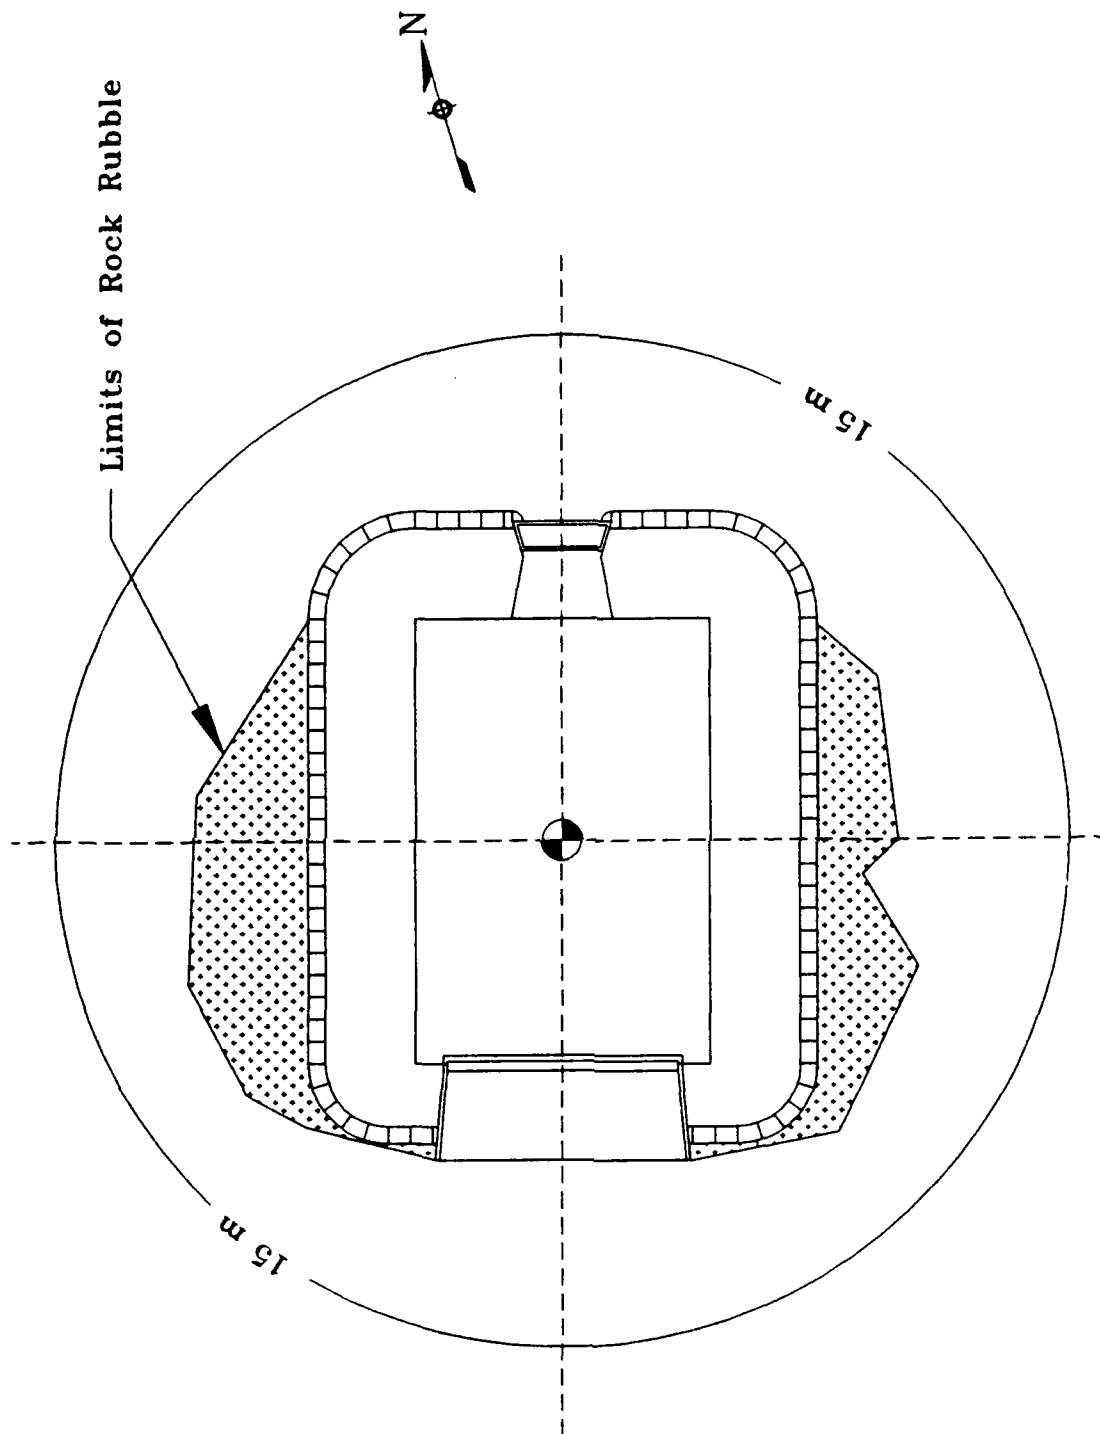
Figure 197. Rock rubble distribution, PAS-2.

All the rock ejected from the berm remained within a range of 15 m of GZ. The limits of the ejected rock were surveyed and are shown in Figure 197.

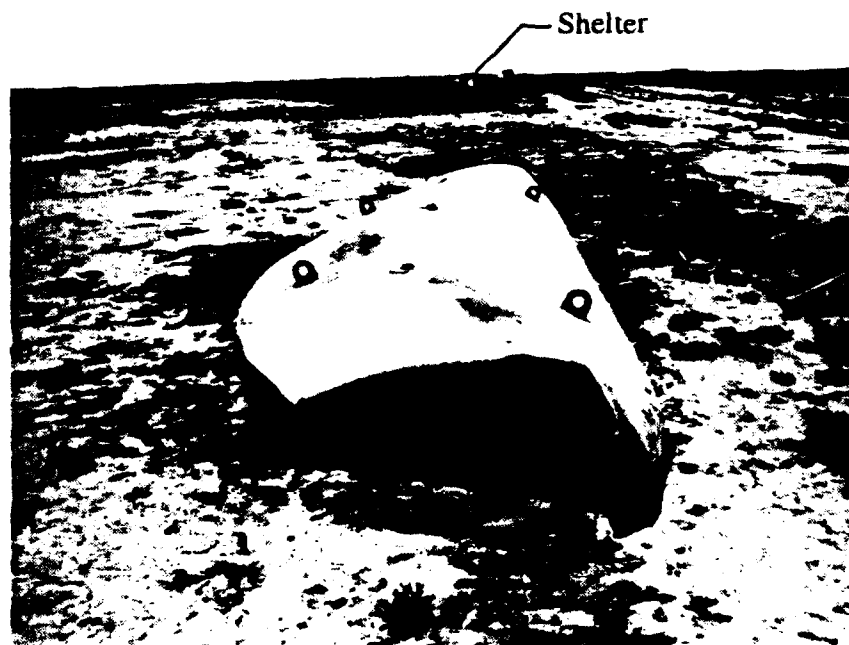
Figure 212. Posttest location of front door, PAS-4.

160 ms after $t = 0$. Its maximum height of flight could not be determined as it left the field of view of most ground-level cameras. It came to rest at 402 m in front of the structure (Fig. 212).

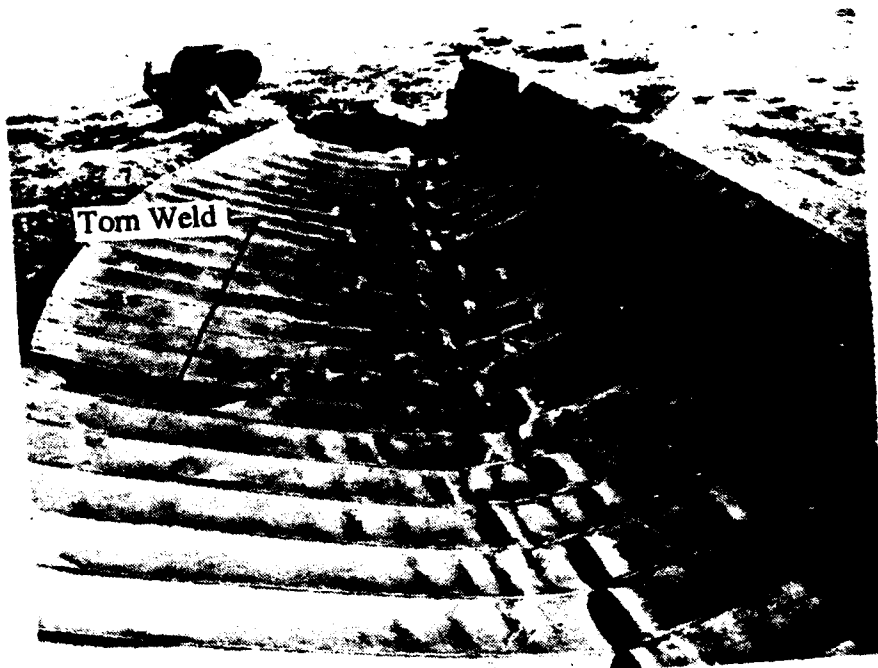
At several locations on the inside surface, the welds joining the inner plate to the internal stiffeners had areas of longitudinal tensile cracks. At two locations near the top center of the door, the inner plate was torn from the internal stiffener along the weld line (Fig. 216). At one location the tear was 620 mm long, and at the other it was 315 mm long. There were also some isolated locations of torn welds in the inner plate around both of the hinges.

Figure 216. Tom weld at inside plate and internal stiffener, PAS-4.

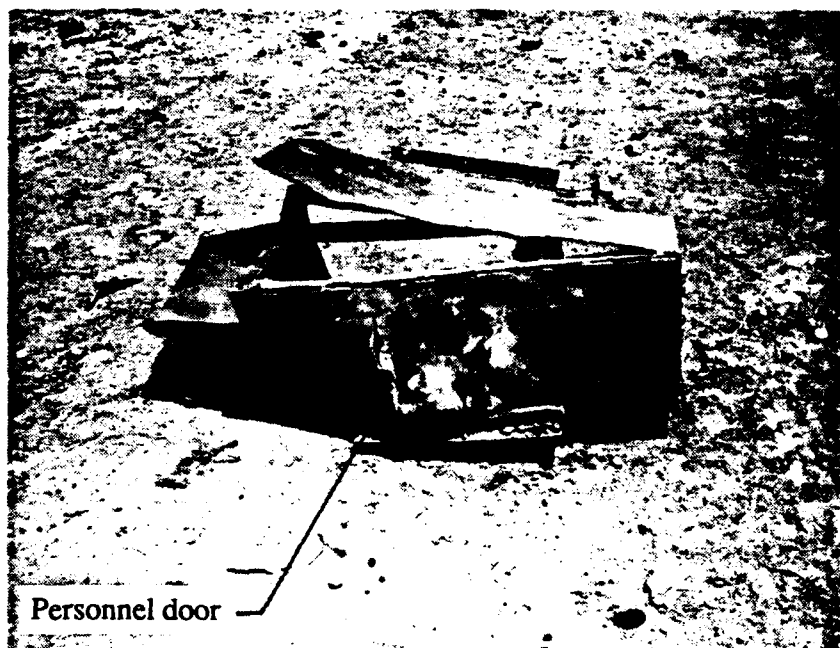
The personnel entrance vestibule was found intact, but severely damaged, approximately 28 m in front of the left wingwall (Fig. 217). The personnel door was found inside the vestibule. It had impacted the inner wall of the vestibule, fracturing the 6-mm-thick steel plate in several places (Fig. 218). The personnel door was deformed to the point of being almost unrecognizable. Although the welds simulating the hinges and latches had all been broken, the door frame remained welded to the steel liner of the headworks.

Figure 218. Vestibule and personnel door (foreground), PAS-4.

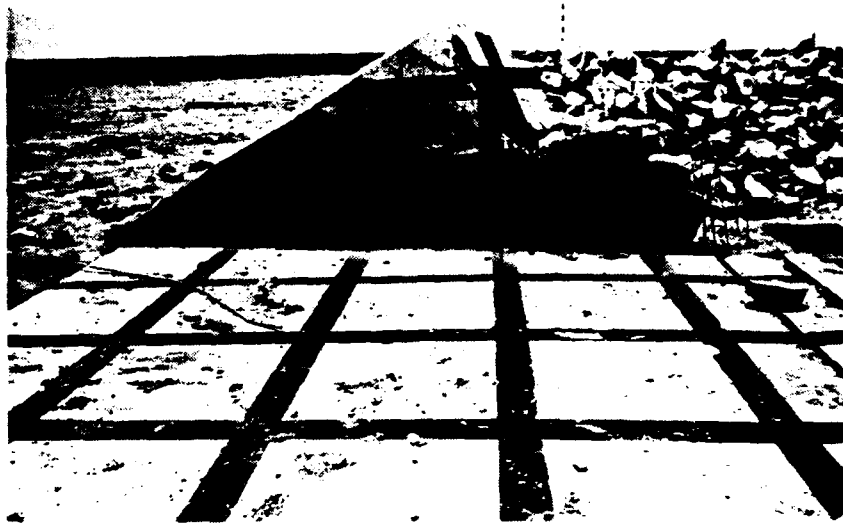
Figure 219. Right wingwall, PAS-4.

The lower portions of both wingwalls were found in place on their foundations (Figs. 219 and 220). Most of the top portion of the right wingwall was found as a single piece of debris about 29 m from the side of the shelter. A large piece of the top portion of the left wingwall was found 45 m in front of the shelter. All of the reinforcing bars crossing the failure planes had broken in tension. Both wingwalls and their foundations had broken away from the front foundation and moved forward about 65 mm.
